# **Stormwater Management Facilities Inspection Report Borough BMP Inspection Report**

**Quarter 4, 2023**

**Bernardsville Borough**  
c/o: John MacDowell

Date of Inspection: December 06, 2023

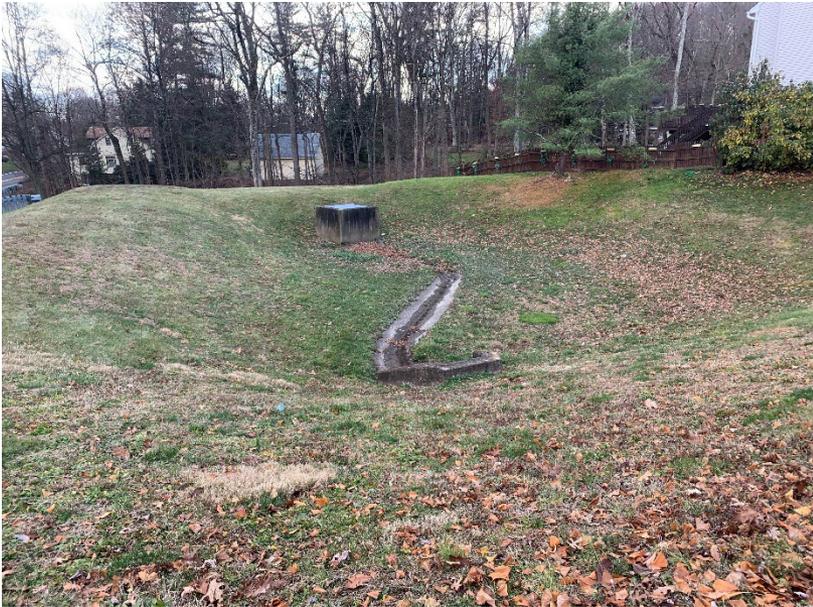
Photo 1

**Overview of the basin**

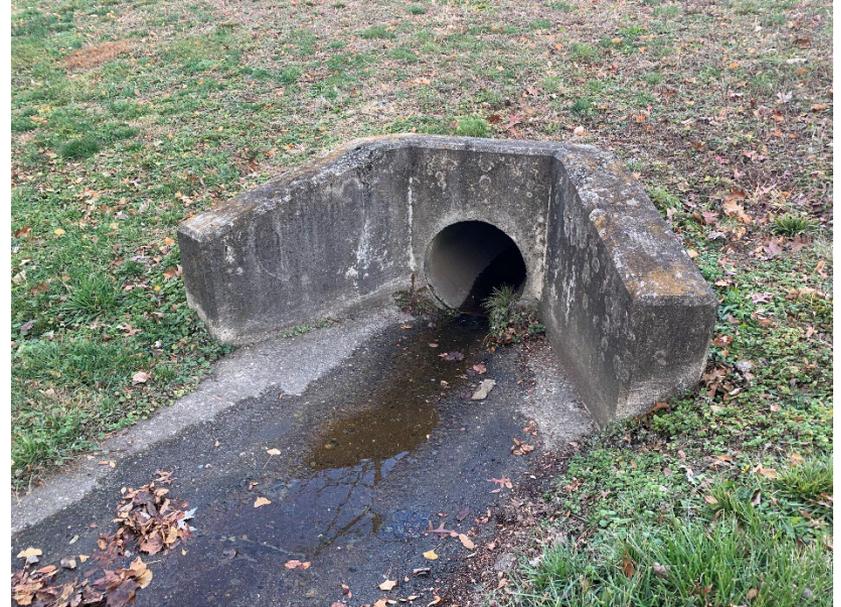
Photo 2

**Single outfall – good condition**

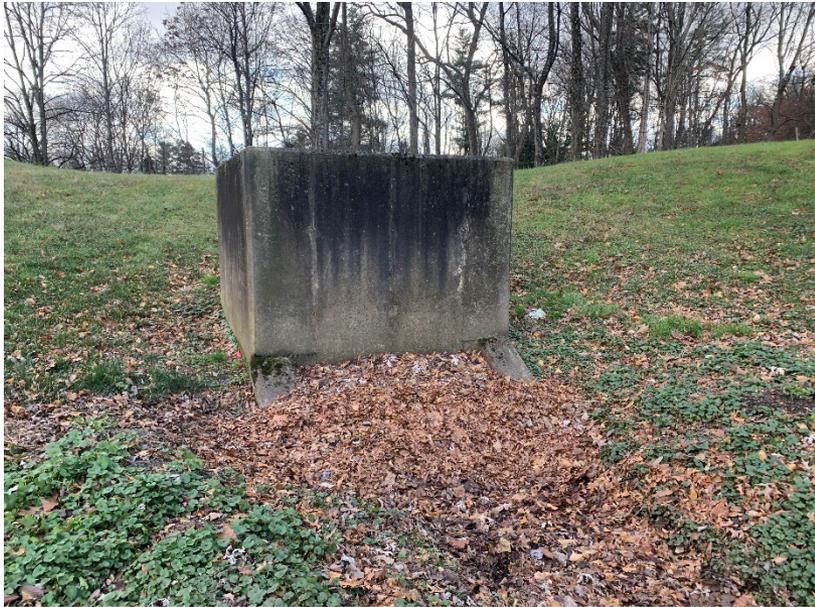
**Photo 3**

**OCS overview – trash rack is covered with debris**

1. Remove debris from the OCS trash rack to allow for proper water flow out of the basin.

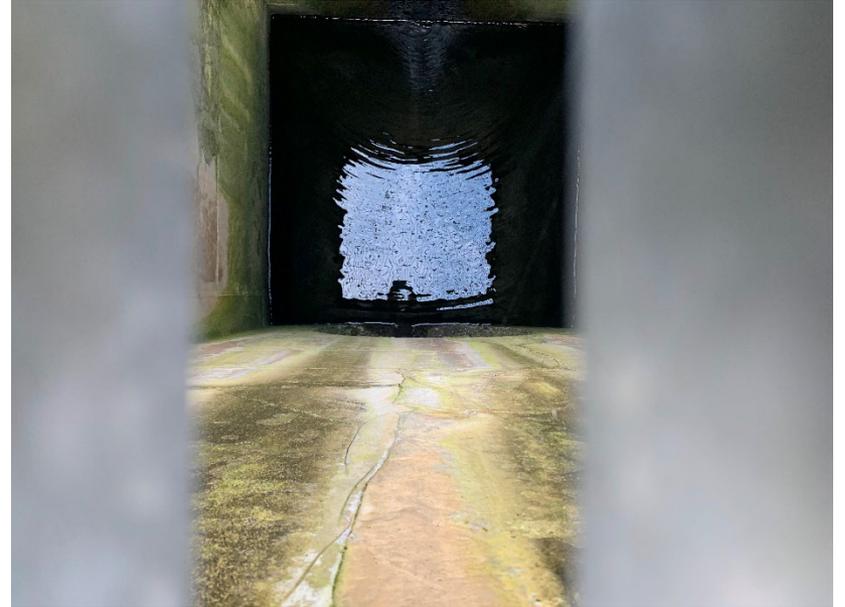
**Photo 4**

**Inside is clear**

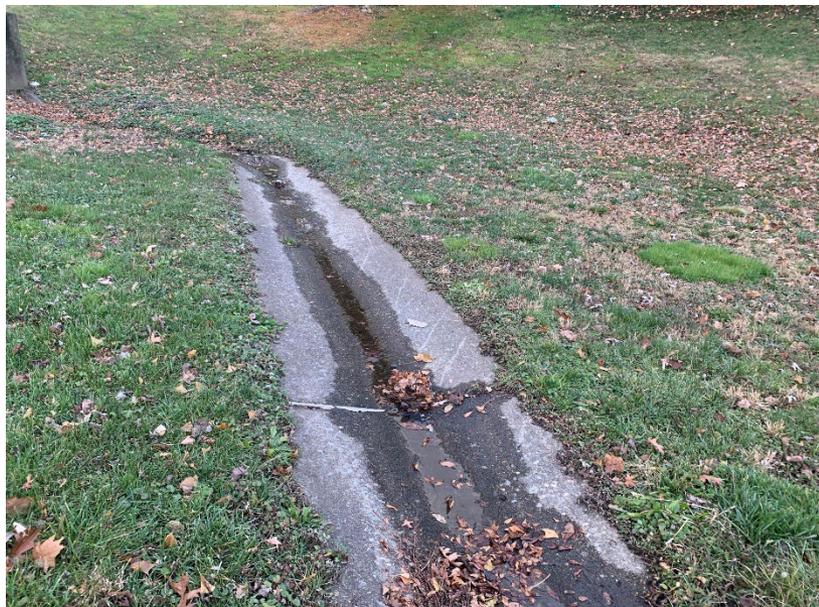
Photo 5

**Low flow channels – minor sediment and debris accumulation**

1. Clean out low flow channels of excess sediment and debris.

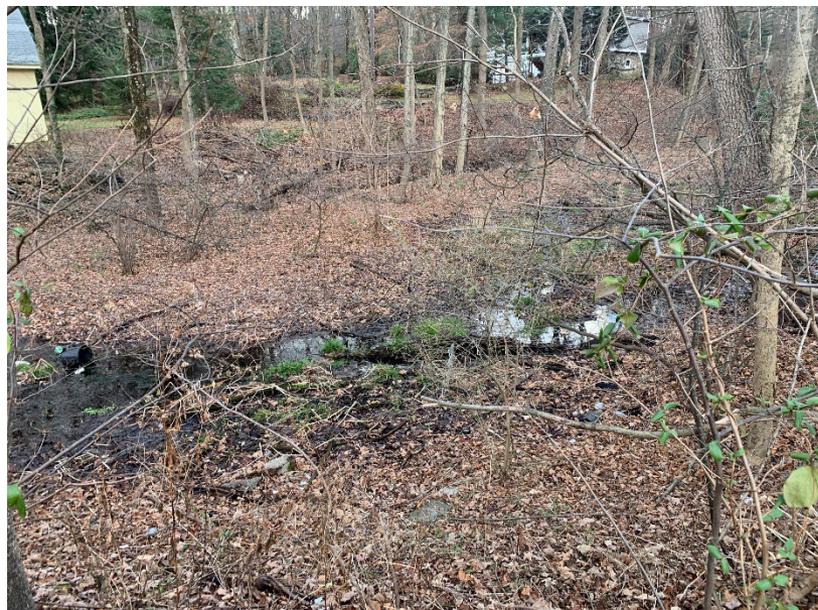
Photo 6

**Discharge area**

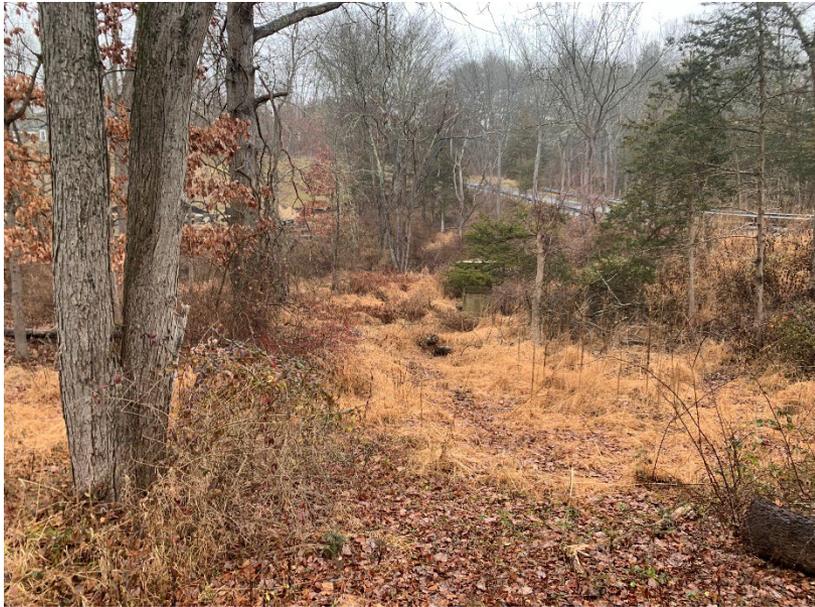
Photo 1

**Overview of the basin -  
overgrown**

1. Cut down and remove all overgrown vegetation inside the basin and around the berms. The removal of woody vegetation must be done under the direction of a licensed engineer to ensure rotting tree stumps/roots do not compromise the integrity of the berm.
2. Remove vegetation and trash from the OCS low flow trash rack. See photo 3.

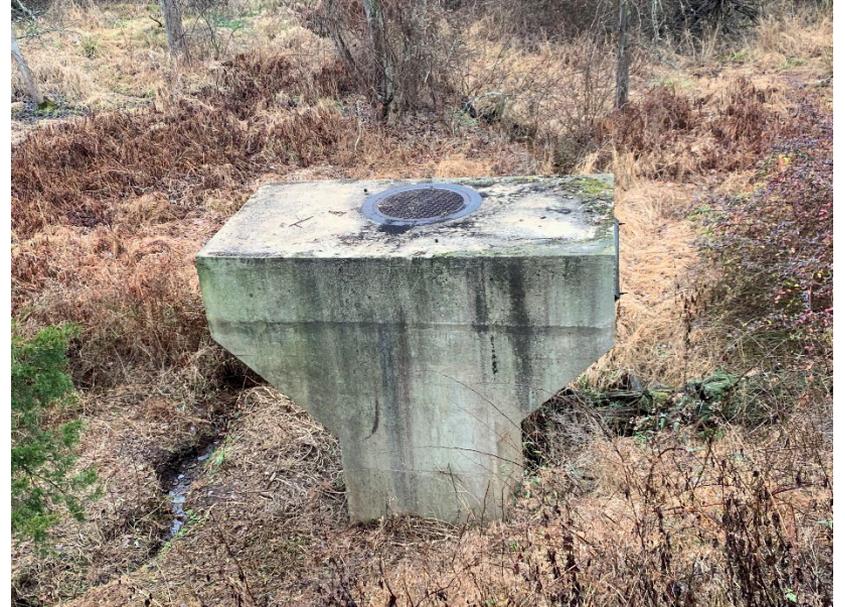
Photo 2

**Overview of OCS**

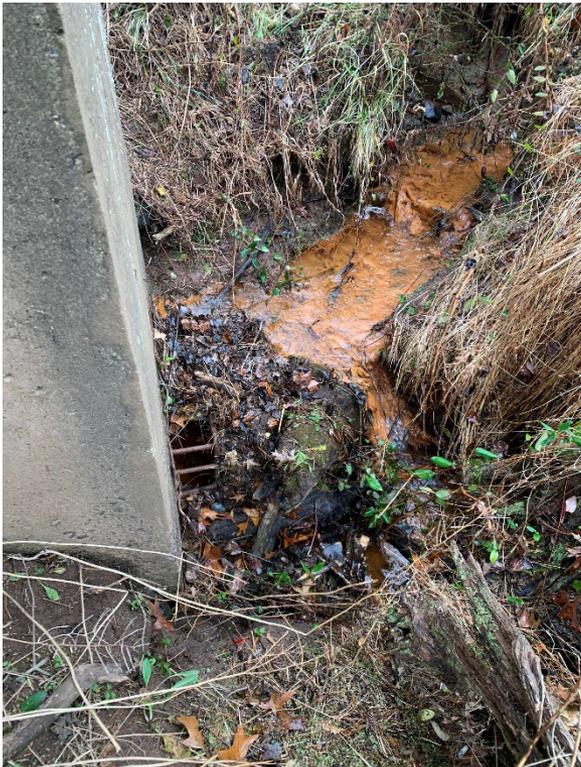
**Photo 3**

**Trash rack on OCS low flow orifice is clogged**

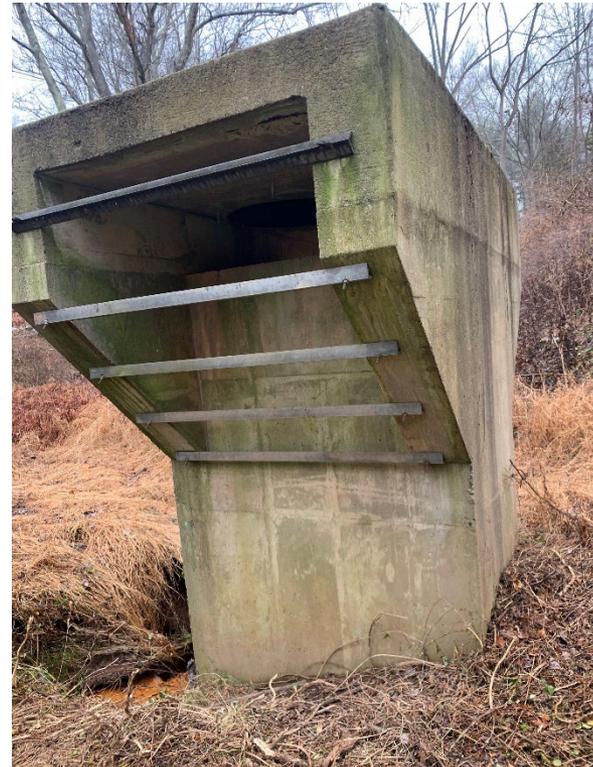
**Photo 4**

**Emergency overflow on each side is in good condition**

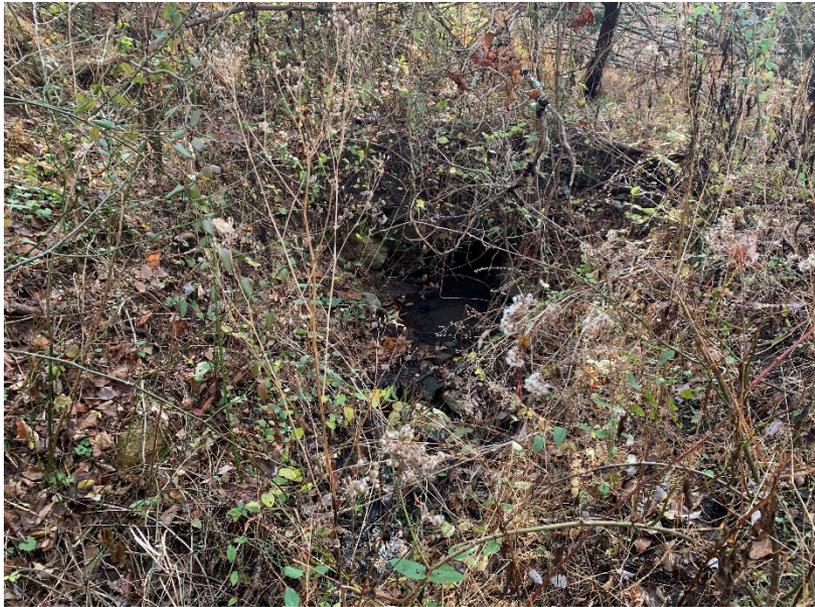
Photo 5

**Single outfall visible –  
overgrown with vegetation**

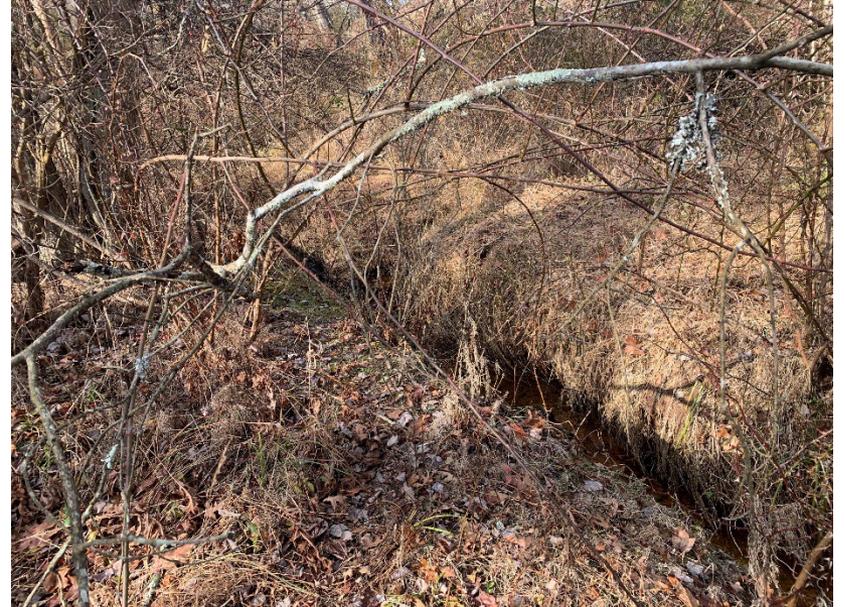
Photo 6

**Dug out channel from outfall  
to OCS**
