Preliminary Investigation

Quimby Lane
Bernardsville, NJ

Topology | 60 Union St #1 Newark, NJ 07105

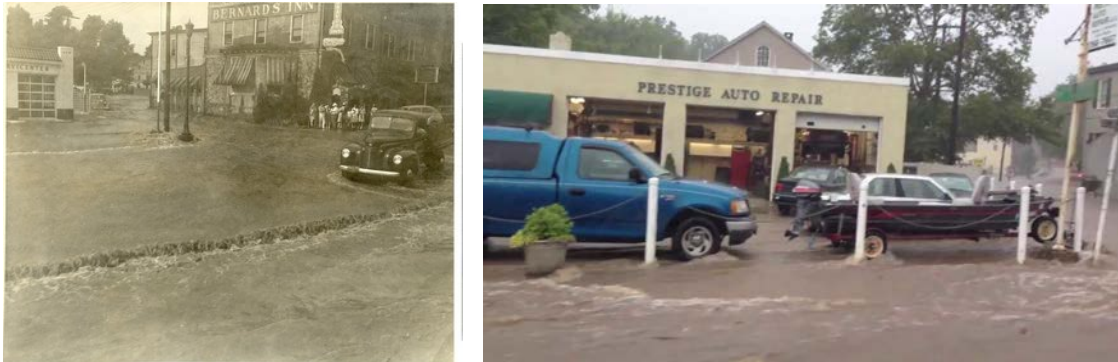
Figure 5: 1942 image showing flooding at the intersection of Mine Brook Road and Quimby Lane, Bernards Inn in the background;⁵ still image from 2013 video showing flooding in roughly the same location⁶

Flooding in the area is a historic and contemporary problem. The images below reflect similar flooding conditions at the intersection of Quimby Lane and Mine Brook Road roughly 70 years apart.

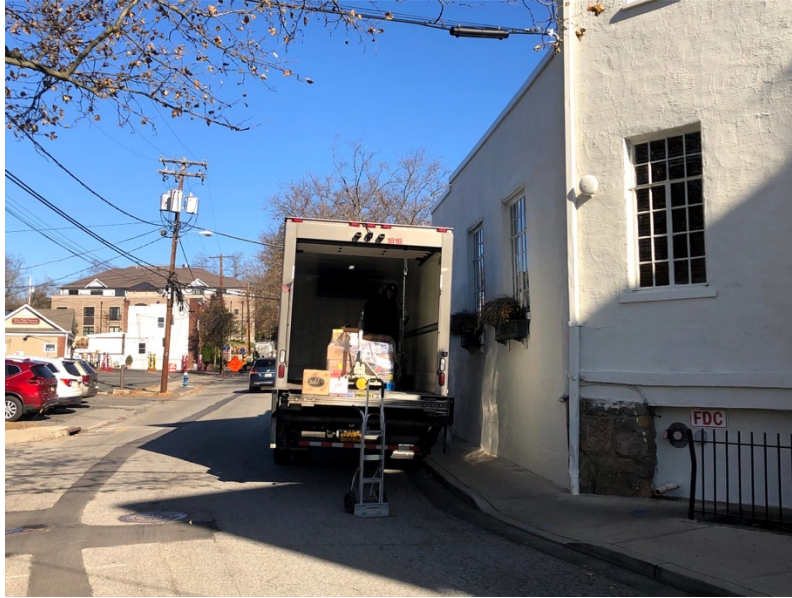
Figure 9: Loading along Quimby Lane

Today, the property has no dedicated on-site loading area that is suitable for accommodating the deliveries that are required to operate a restaurant and hotel. As a result, deliveries commonly take place on Quimby Lane in an informal loading area marked with “No Parking” signs. This condition is reflective of an obsolete layout and faulty arrangement. It impedes the flow of traffic on Quimby Lane and creates a safety hazard by impeding visibility for motorists and pedestrians. Loading along the eastern sidewalk of Quimby Lane, as reflected in the image below, creates increased opportunities for conflict points between vehicles and pedestrians.

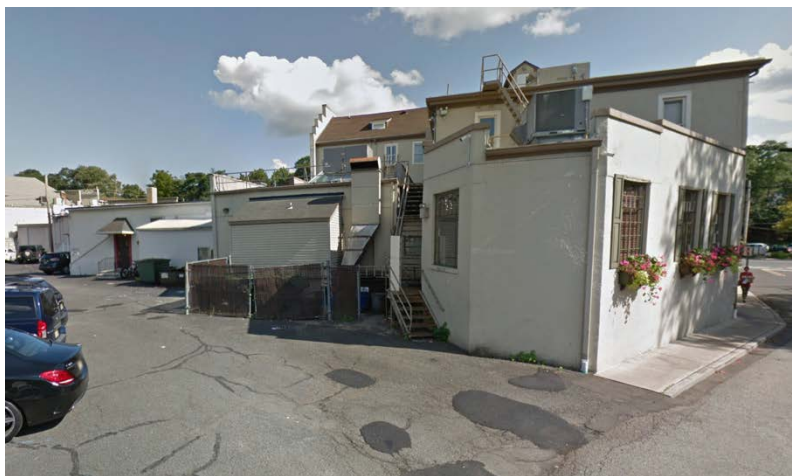
Figure 10: Blind turn in conflict with staircase access; trash area with no marking or striping

Faulty arrangement is also observed in the rear of the property. There is a rear entrance to the building that is accessed via a staircase. Individuals exiting this staircase do so onto an unmarked access driveway that is shared with the adjacent lot. The intersection of this driveway and the staircase creates a blind turn that is dangerous to pedestrians and motorists alike. This condition is magnified by the lack of striping or marking denoting drive lanes in the rear of the property.

The trash area in the rear of the property is also reflective of a faulty arrangement. While the trash area is adequately screened, there is no visual indication of how trash collection is supposed to take place. If trucks collect the trash where it is stored, they will halt the flow of circulation to the parking area of the adjacent property, resulting in a system that is not only inefficient, but also dangerous.

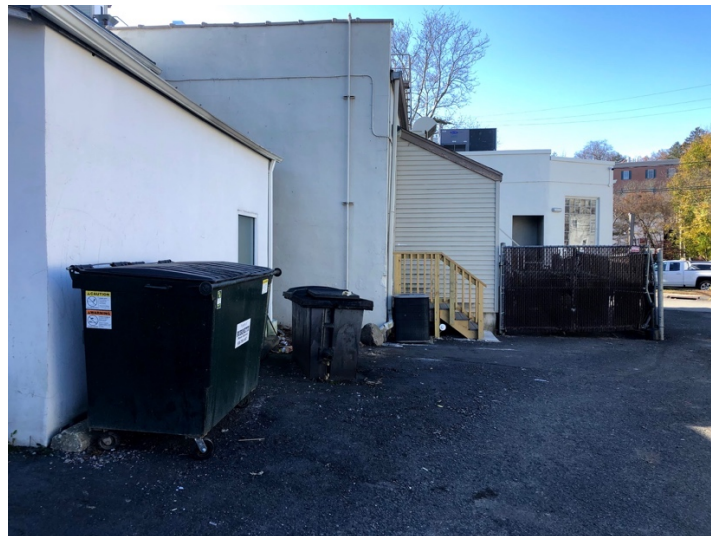
Figure 12: Dumpster area lacks screening or striping

The property as currently configured also exhibits faulty arrangement of sanitary and waste management facilities. Dumpsters located in the rear of the structure fronting on Mine Brook Road lack enclosures and screening. An additional dumpster is located in a parking space, straining the already limited parking inventory. The duration of its placement in the parking space (Google Street View imagery indicates it has not been moved since 2016) reflects the permanent nature of its placement in an inappropriate location. The duration of its placement reflects not a momentary misplacement, but a persisting condition of faulty arrangement, mismanagement, or both. This arrangement of sanitary and waste management facilities, specifically the lack of enclosure and screening is detrimental to health, safety, and welfare of a community as failure to adequately store and secure trash can attract vermin, detract from the aesthetic quality of a place, and cause waste to spread to adjacent properties or natural environments.

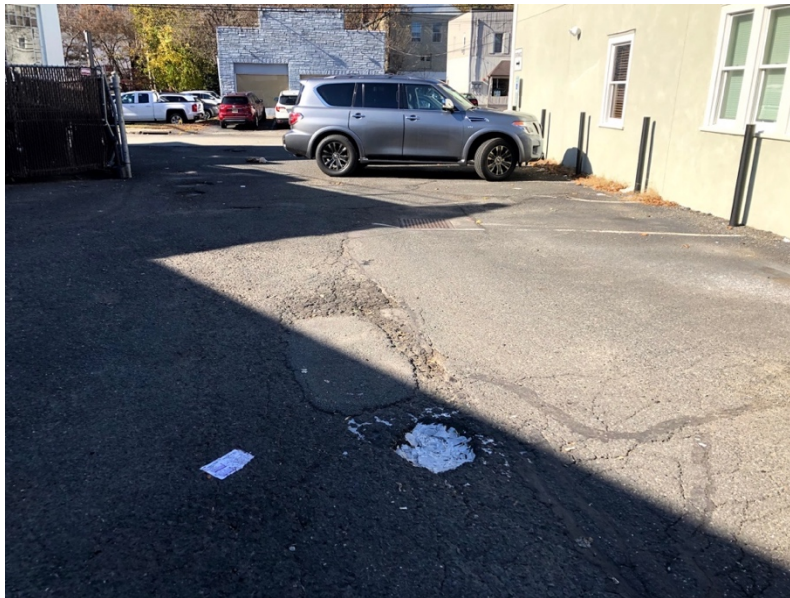
Figure 14: Dilapidated improvements; narrow area for vehicular circulation

The property also possesses dilapidated improvements. Pavement in the parking and circulation area exhibits cracking and other signs of deterioration as reflected in the figure below.

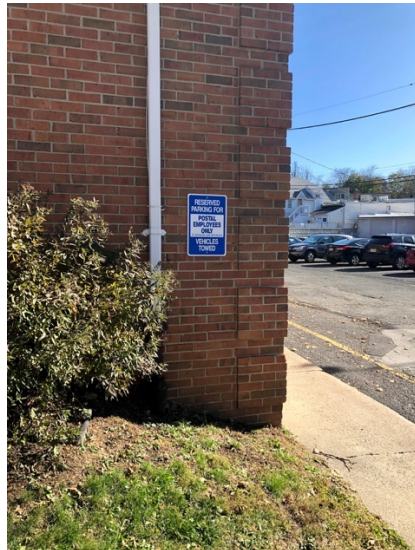
Figure 16: On-site parking restricted for employee use

space for every 200 square feet of area. Based on available tax records, the area of the Post Office is 6,694 square feet. Based on these figures, roughly 33 spaces should be provided on site. While the Borough's code is informative, it is not an ideal standard for estimating required parking considering modern standards for parking requirements around transit. Using a more modern standard figure of 3.0 spaces per 1,000 square feet of commercial area located near transit, the required number of spaces is roughly 21. While the site does include 15 parking spaces for cars and 8 for mail trucks, these spaces are clearly marked for employee use.

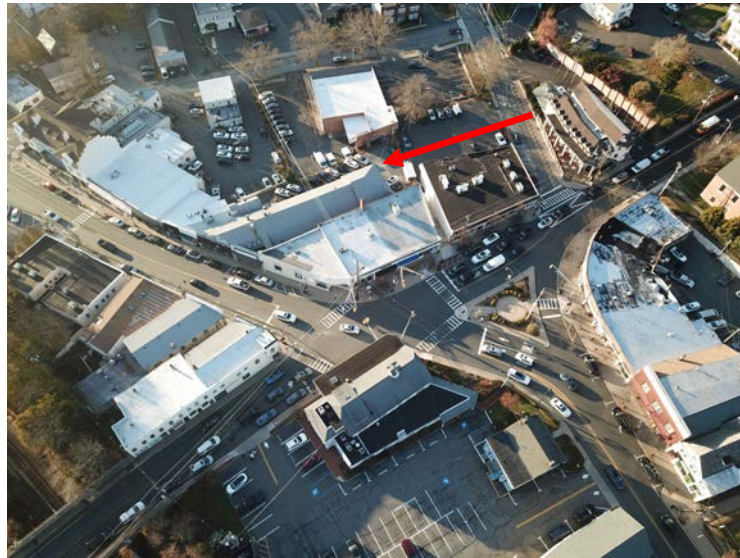
Figure 17: Access to loading for Lot 6 only possible via Lot 5

The property possesses a title issue related to vehicular access from the adjacent commercial property, Block 70 Lots 6, 6.01-6.08 (henceforth referred to as Lot 6). Access to the rear loading and parking area for Lot 6 is primarily provided via the parking and loading area located in the rear of Lot 5. The only other access point to the rear of Lot 6 is via a narrow driveway located between the two buildings. This driveway is of insufficient width to accommodate deliveries or access for larger passenger vehicles. The relationship between the two properties is reflected in the figure below.

Because access to the rear of Lot 6 for loading needs to happen by crossing Lot 5, this creates a title issue on Lot 5. Based on title research and a conversation with one of the owners of a Lot 6 property, there is no formalized easement in place permitting tenants of Lot 6 to use this access point. Nevertheless, this condition exists and, based on historic imagery and conversations with property owners, has existed for several decades. The duration of this condition creates the potential for a legal claim to enforce continued access.

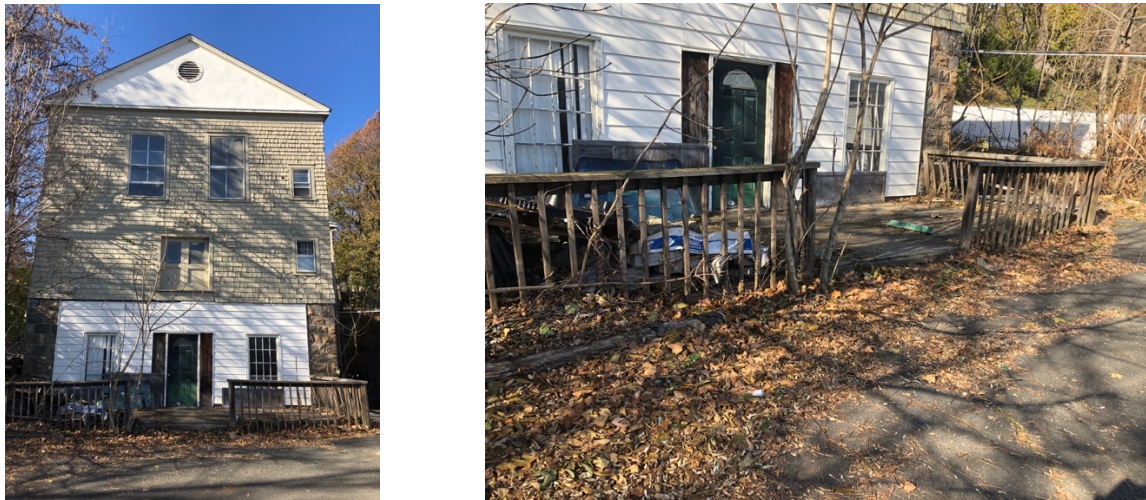
Figure 22: Bridge connecting the two sides of the property over the Mine Brook

The design of the structure on Lot 4 in a way that requires a bridge to access both sides of the property, as reflected in the images below, is reflective of a faulty arrangement that increases flooding risks. As a result, the property qualifies as an Area in Need of Redevelopment under Criterion D.

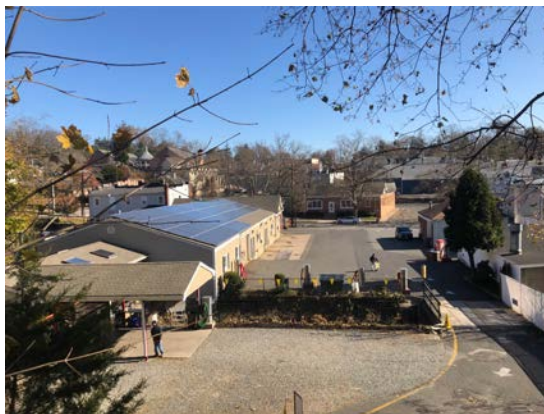
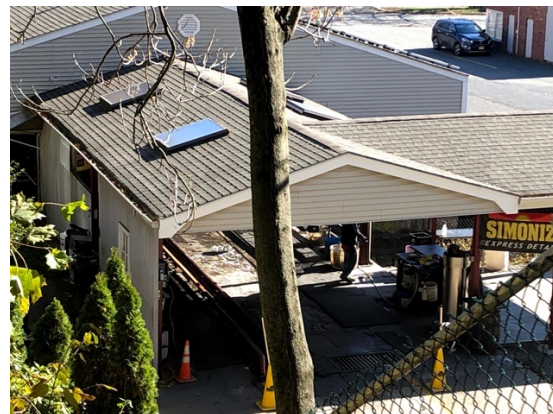
Figure 23: Circulation pattern requires vehicles to cross the Mine Brook; car wash activities take place above the Mine Brook

then rerouted back through the primary structure before existing back onto Quimby Lane. This pattern is reflected in the figure and image below.

This vehicular pattern is reflective of a faulty arrangement and the inappropriate configuration of the site for the current use. Requiring vehicles to cross the Mine Brook for their car wash, and then performing car washing activities while on a bridge over the Mine Brook, creates health and safety concerns, particularly given the use. Carwashes create runoff, both from materials used in the cleaning process, and from the residue that emanates from vehicles undergoing the washing process (auto fluids, oil, road grime, etc.). The intimate intermingling of this use with the Mine Brook is reflective of a faulty

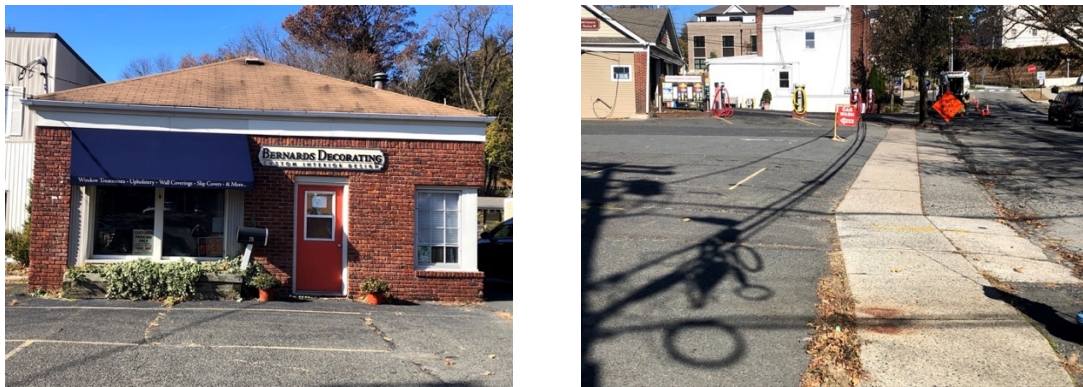
Figure 24: Improvements are cracked and in need of repair; circulation pattern is poorly striped

The condition of the parking area on site is also reflective of qualification under Criterion D. The parking surface and adjacent sidewalk are cracked and in need of repair and resurfacing. These dilapidated improvements have detrimental impacts on health and welfare by discouraging investment and detracting from the attractiveness of the pedestrian environment.

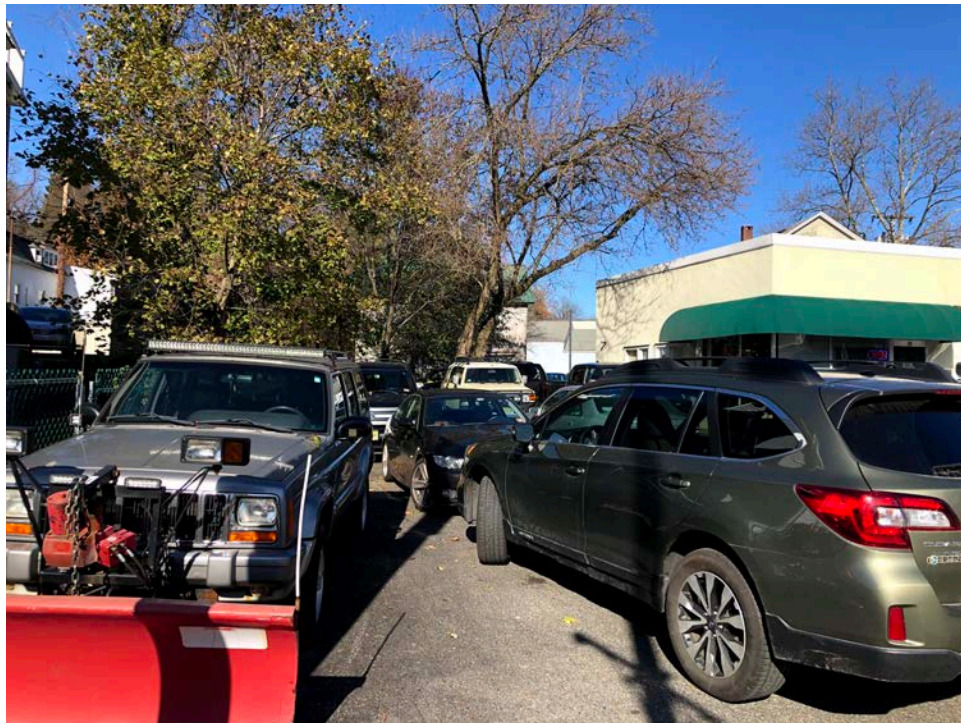
Figure 29: Vehicles are stored in the front of the property with no screening or logical arrangement

Faulty arrangement is also reflected in the haphazard way vehicles are parked and stored on the site. Vehicles are parked in the front yard, an unattractive arrangement that can discourage visitors from shopping in and patronizing the downtown's businesses. No effort is made to screen vehicles in the manner required by standards in the Borough's zoning ordinance for auto sale shops, a use that is similar but less intense. Haphazardly storing vehicles in the front yard with no screening or organization is reflective of a faulty arrangement that is detrimental to the welfare of the community.

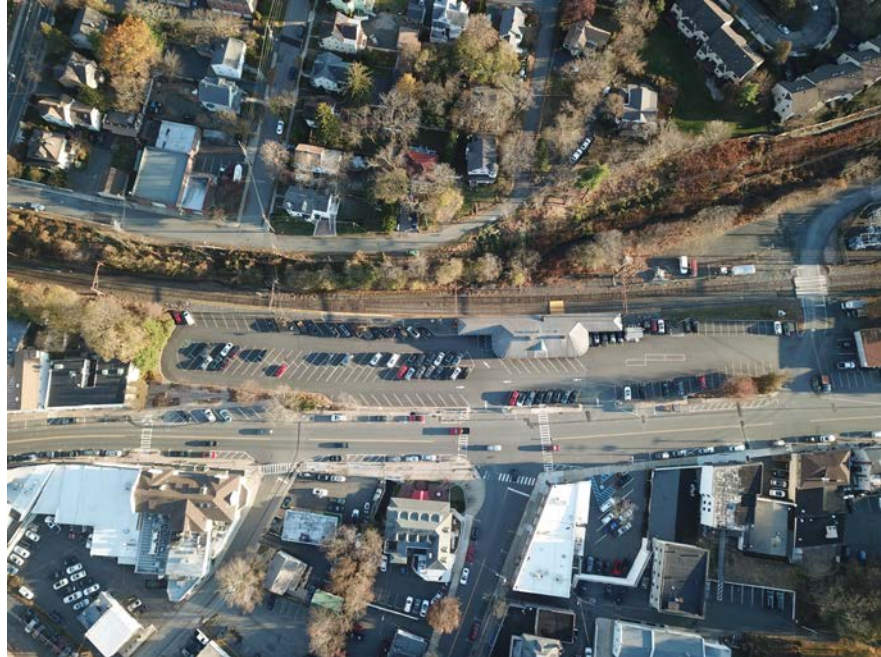
Figure 30: Uses on the property include surface parking, substation; areas to the south lack a connection to the property

The property also exhibits faulty arrangement, largely stemming from the presence of a utility substation within the Regulatory Floodway. The placement of infrastructure within the Floodway is a condition of faulty arrangement that is detrimental to the health, safety, and welfare of the community. Should the substation be compromised by a flooding condition, this would present a disruptive outcome that would create safety concerns and limit the functionality of the property.
